## Technology Evaluation

Forensic Technology Center of Excellence:  
Validation and Evaluation of Magneto-Optical  
Imaging Technology for Recovering Obliterated  
Serial Numbers in Firearms

### FINAL REPORT

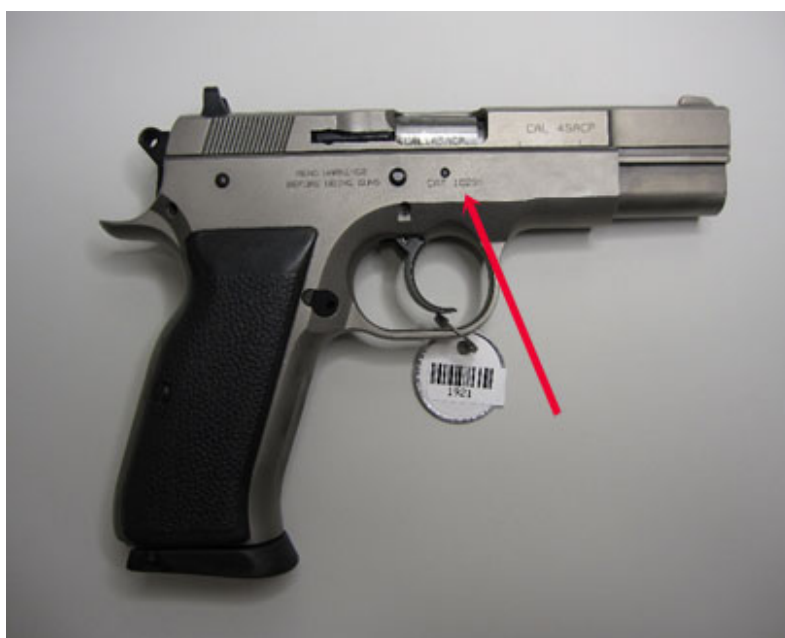
**Figure 1. Tanfoglio Witness pistol with dot pin-applied, and grinding and sanding removed, serial number.**

When a serial number impression device imprints the identification number, the crystalline structure of the metal is deformed and compacted a short distance beneath the identification number. Two deformation zones result from the impression process: plastic and elastic. The plastic deformation zone is permanent, while the elastic zone is not. If the zone of plastic deformation is still present after a serial number alteration or obliteration (**Figure 1**), it is possible to detect and visualize the serial number. Recovery of an obliterated serial number greatly depends on the material used in the manufacturing of the firearm and the depth of the obliteration.

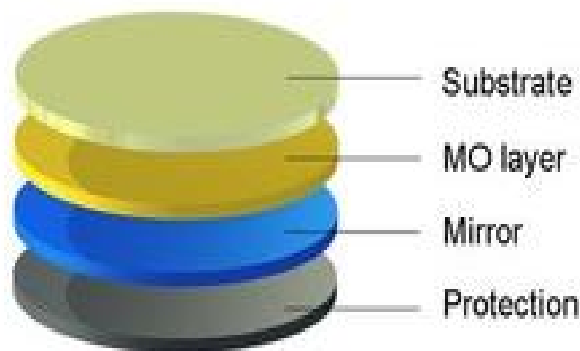
The MO sensor is made up of four functional layers (**Figure 2**). The substrate layer consists of a gadolinium gallium garnet (GGG) with good mechanical, thermal, and optical properties. Next is the MO layer: a single crystalline bismuth and gallium substituted rare earth (RE) iron garnet grown on the GGG substrate by liquid phase epitaxy. A thin mirror to reflect the light passing through the MO layer represents the third layer. The three layers are followed by a diamondlike-carbon (DLC) layer to protect the film and guarantee its durability.

**Figure 2. MO sensor configuration showing the four functional layers.**

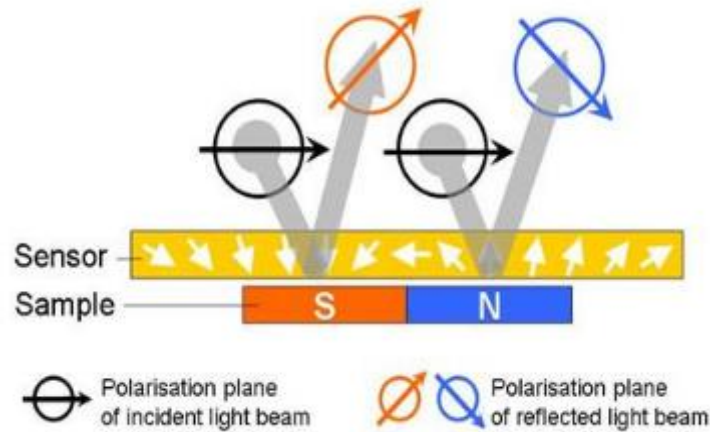
To image a magnetic field, the MO-sensor is placed directly onto the magnetic material of interest and illuminated with polarized light. Light passing through the transparent MO-sensor layer is reflected by the mirror coating, causing the light to pass through the MO-sensor once again. When this happens, the plane of polarization is rotated by the magnetic field in the sample. Using an analyzer-polarization filter module, an intensity contrast image is created that is based on the north-south pole components of the magnetic sample (**Figure 3**). Mapping the magnetic properties of the sample object is performed along the x-y plane over the entire sensor size to visualize and analyze both static and dynamic magnetic field changes. The result is an optical image in real time representing a 2D cut through the magnetic stray field of the sample.

**Figure 3. Rotation angle differences caused by the magnetic field's poles of the magnetic material. S and N denote the south-to-north orientation of the sample (source: Matesy GmbH).**

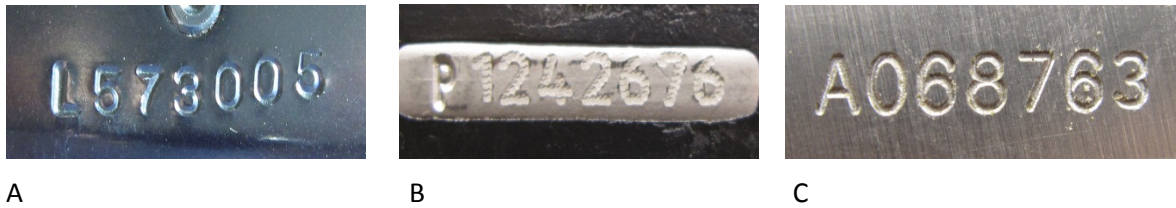
Three different serial number application techniques were examined: stamping, dot peening, and laser etching (**Figure 5**). Stamping was selected because it is the traditional marking method for firearm serial numbers, and dot peening and laser etching were incorporated because they are becoming increasingly popular as marking techniques. Stamping and dot peening belong to the class of deforming marking methods because they apply the mark by impact or compression, resulting in a permanent alteration of the physical properties of the material in the marked area. Laser etching removes metal by vaporizing it on contact, leaving no deformation and only a heat-affected zone with little information.

**Figure 5. Stamping (A), Dot Peening (B), and Laser Etching (C) applied serial numbers showing differences in quality marks.**

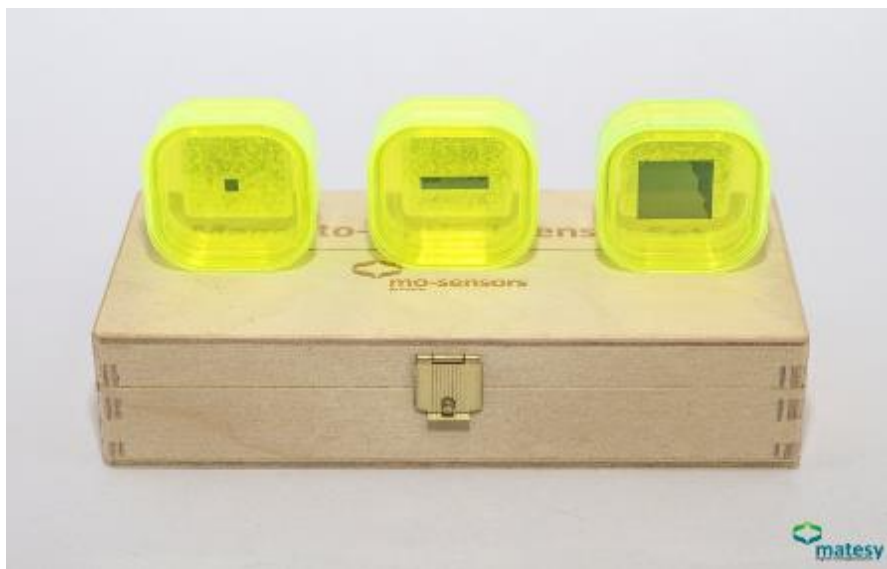
The workstation used to validate the imaging and recovery capabilities of the MO sensor technology consisted of a portable desk lamp, a digital camera, a forensic photography stand, a permanent magnet, and a three-piece MO sensor kit (**Figure 6**). The MO sensors used were all of the Type A variety having dimensions of 3 x 3 mm, 17 x 5 mm, and 17 x 15 mm, supplemented by one irregularly cut piece. The desk lamp consisted of a base and a flexible light guide equipped to hold a 150-W fluorescent light bar for diffuse illumination of the sample. The underside of the light (exposed portion) was covered by a film sheet of cut-to-fit linear polarized film. A horseshoe magnet and two small RE magnets were used as needed to induce magnetic fields.

**Figure 6. MO sensor kit showing the three sensor sizes used in the project.**

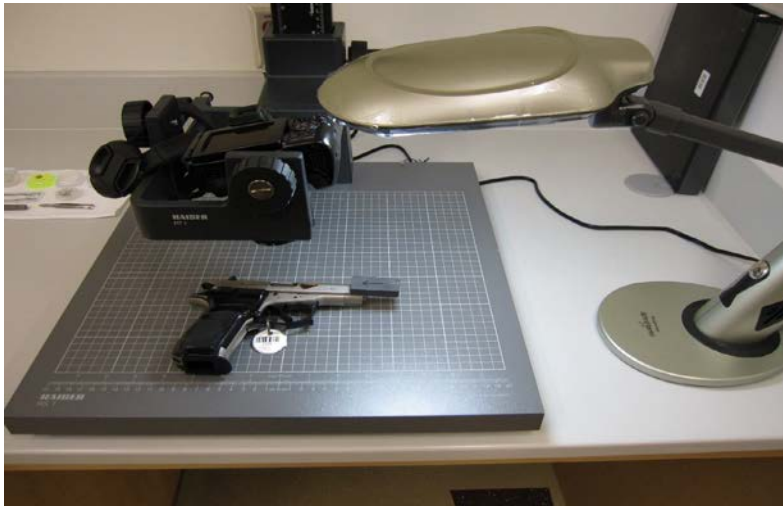
equipped with both a Tiffen 58-mm linear polarization filter and a Hoya 58-mm circular polarization filter to serve as analyzers. It was mounted on a portable copy stand for forensic photography. The stand featured an adjustable column to position the camera at the required height and a flexible camera mount to angle the camera to the desired setting. The base of the stand consisted of a rectangular baseboard etched with a 1-inch grid for scaling. Not including the size of the sample, the footprint of the MO sensor technology workstation (**Figure 7**) was approximately 20 x 18 inches or 50 x 45 cm (WxD).

Figure 7. Experimental setup of the MO sensor workstation at the JoCo facility.

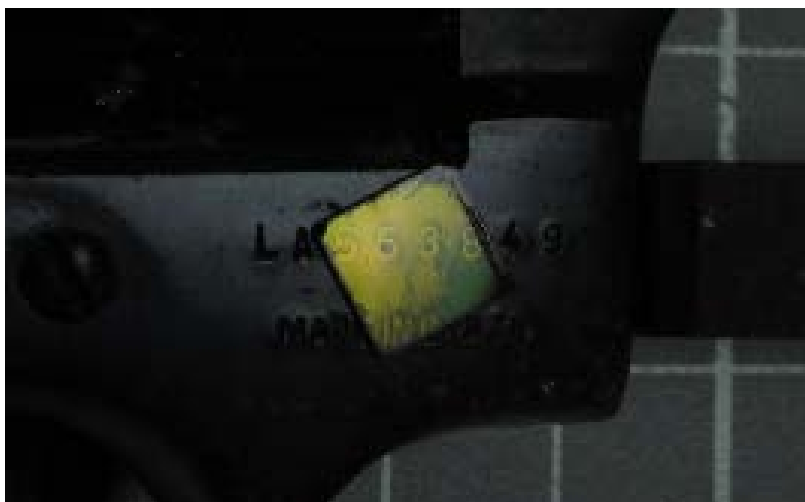
Tests were performed at the JoCo Sheriff's Office crime lab facility in Olathe, KS, with firearms selected from the JoCo Firearm Reference Library (FRL). Prior to obliterating the serial number, the characters were recorded in a ledger and viewed with the MO sensor technology (**Figure 8**). This was done to confirm the sensor's ability to visualize the unaltered serial number on the firearm and to determine the best location(s) for placement of a magnet. The former was to validate the experimental setup and the method used to recover obliterated serial numbers. It was assumed that if the MO sensor film was unable to visualize the serial number prior to removal, it would be unable to do so after removal as well.

Figure 8. MO sensor methodology confirmatory step showing stamped alphanumeric characters.

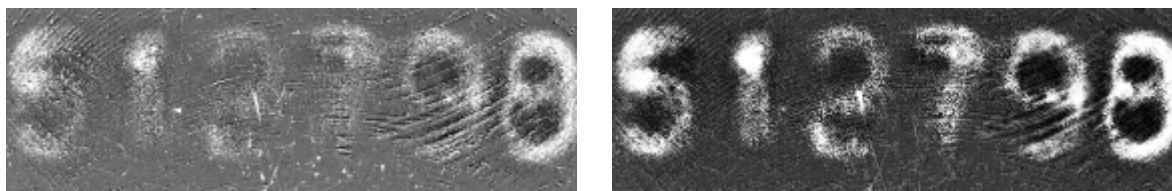
Adobe Photoshop CC is an image editing application used in forensic analysis (Malikowski, 2004). In this project, it was used to develop a methodology to improve the character recognition of the MO sensor technology and to digitally enhance the image of partially recovered serial numbers. Utilizing a high-resolution image of a partially recovered serial number (**Figure 9A**), with all characters recorded before obliteration, a process was developed to restore the unclear characters until they became fully identifiable (**Figure 9B**). The process consisted of a series of contrast improvement and noise and visual reduction steps (Maini and Aggarwal, 2010). The process was then converted into a methodology (Appendix A) and applied to the partially recovered serial numbers of three different application techniques (laser etching, dot peening, and stamping). This was done to determine the value added of Adobe Photoshop CC image enhancement.

**Figure 9. Enhancement of partially recovered numeric characters (A) to a fully recovered serial number; (B) utilizing Adobe Photoshop CC.**

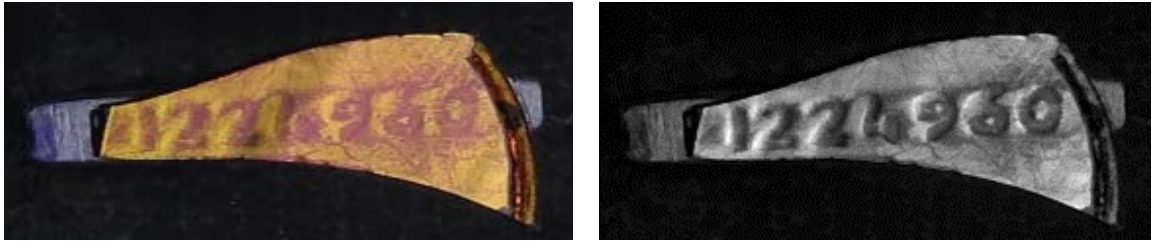
**Figure 10** shows the results for the partially recovered dot pin-applied and hand-filed obliterated serial number. In the original photograph, the first three numeric characters are visualized as well as the last two. Yet, the two numeric characters in between these two sets are somewhat unclear. Utilizing the Photoshop character restoration methodology, all seven characters were digitally enhanced, leading to full recovery of the obliterated serial number applied by dot peening: 1224960.

**Figure 10. Serial number restoration of dot-peened characters utilizing Adobe Photoshop CC.**

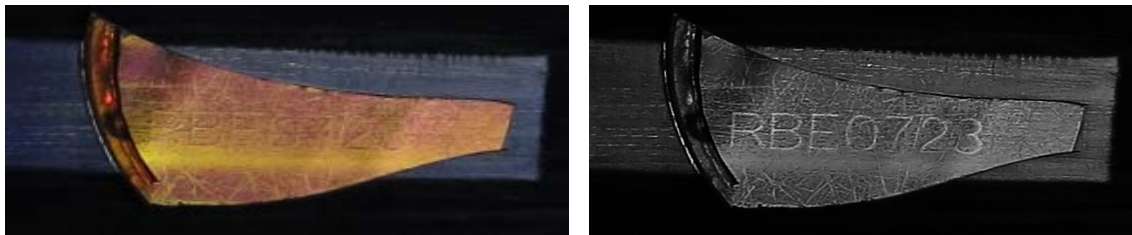
**Figure 11** shows the results for the partially recovered laser etch-applied and hand-filed obliterated serial number. Like the previous photograph, hand filing of the serial number led to the removal of the serial number, which could be visualized but not clearly identified due to a lack of contrast and clarity. Use of the Photoshop character restoration methodology provided a sharper image and more contrast between the individual characters. The result was full recovery of the original laser etch-applied serial number: RBE0723.

**Figure 11. Serial number restoration of laser-etched characters utilizing Adobe Photoshop CC.**

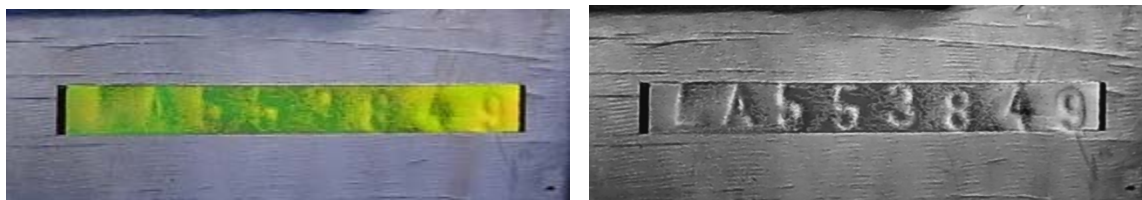
Finally, **Figure 12** shows the result for the partially recovered stamping-applied serial number. Although the characters were visible, their images were difficult to identify with certainty. For example, it was unclear if the serial number consisted of seven or eight characters. After an in-depth review of the negative images, it was decided that the serial number consisted of eight characters. Use of the Photoshop character restoration methodology yielded the serial number: LA553849.

**Figure 12. Serial number restoration of stamped characters utilizing Adobe Photoshop CC.**
